## Report 04-03-00974 Rev. 0.00

DSB - Expert Assessment of IC4/2

## EXPERT ASSESSMENT REPORT IC4/2

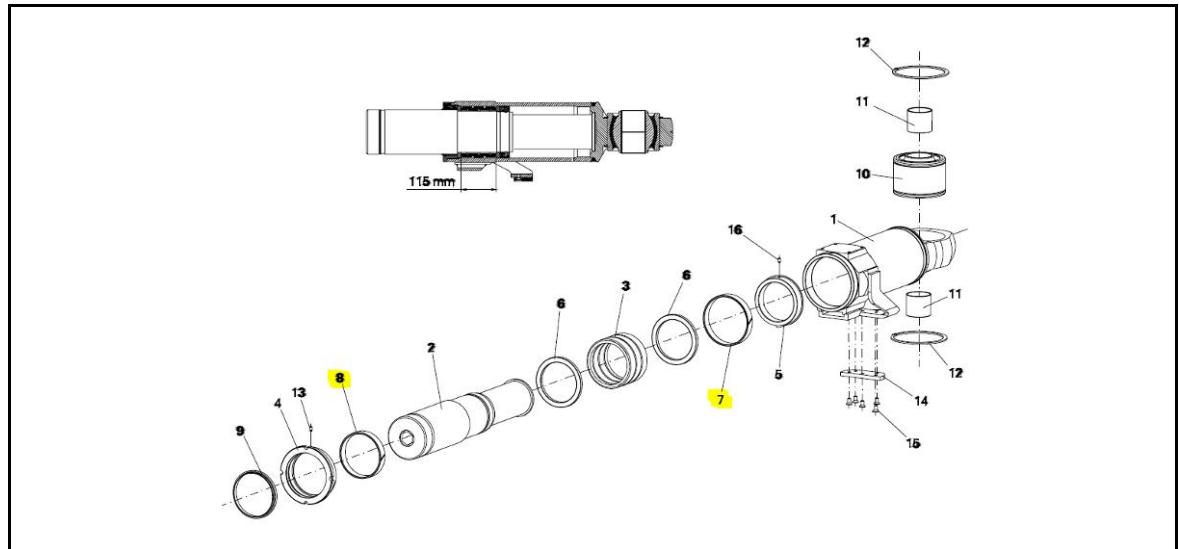
figure 10-2: Overview of the coupler buffer with bearings yellow marked (7, 8) (A2, 159)

The extraction and retraction of the coupler is guided by two bearings (bushings) (7, 8 in figure 10-2) that are positioned between the buffer tube (1 in figure 10-2) and the hydraulic buffer (2 in figure 10-2) within the Dellner coupler.

In March 2014 DSB reports, that the outer diameter of the bearing is bigger than the inner diameter of the pipe, where the bearings are placed in (A2, 210).

Dellner stated that the bearing is oversized because of some expansion as the bearings have the potential to take on some moisture. Since the coupler has been placed for a longer time under unknown conditions, Dellner stated that the moisture could be the potential root cause (A2, 211).

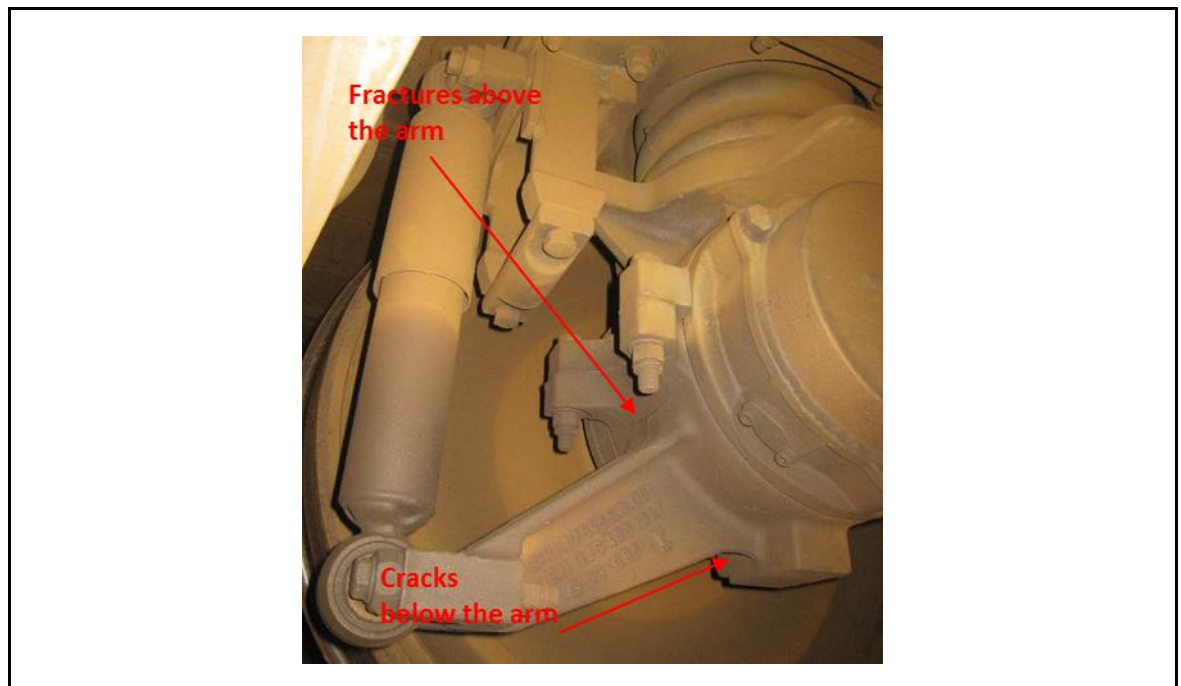
figure 10-6: Primary damper supports at the lower part of the axle box housing

Cracks and fractures at the primary damper supports (figure 10-6) at the lower part of the axle box housing (herein after called “damper support”) is one of the main topics which has consumed a high amount of additional resources for inspection in the workshop. This prevents the achievement of the goals set by the deployment plan (A2, 015) primarily in respect to CFG implementation (MDBF performance).

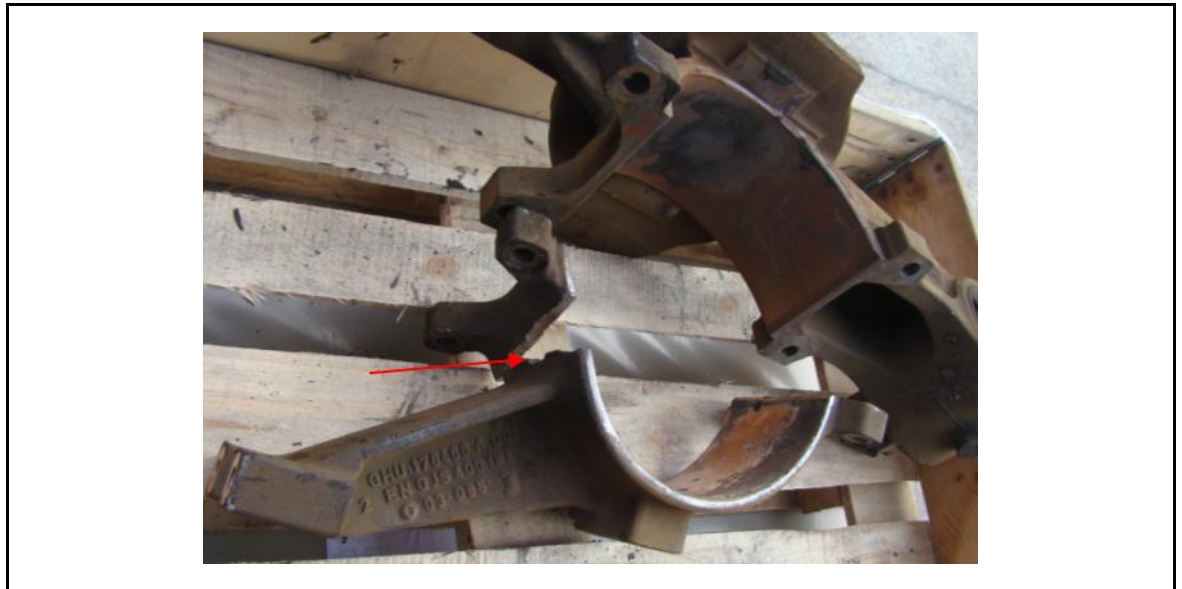
- A) 3 fractured damper supports in the area over the arm close to the casting edge (have been only on the leading trailer axles) see figure 10-7.  
1 crack at the damper support in the area over the arm (on a driven axle)
- B) 5 cracks at the damper supports in the area of the bottom part, at the reinforcement under the arm have, which is the most vulnerable place for fatigue cracks concerning the maximum permissible stress level as predicted by the FEM calculation (A2, 117) see figure 10-8.

**figure 10-7:** Fractured primary damper supports above the damper support arm

A strong indication for the finding above mentioned under 3. is given by the fact that there has been found three (3) broken damper supports over the arm close to the casting edge (figure 10-7) on the leading axles and 1 crack at the damper at the same place (support over the arm) on a driven axle (A2, 340).

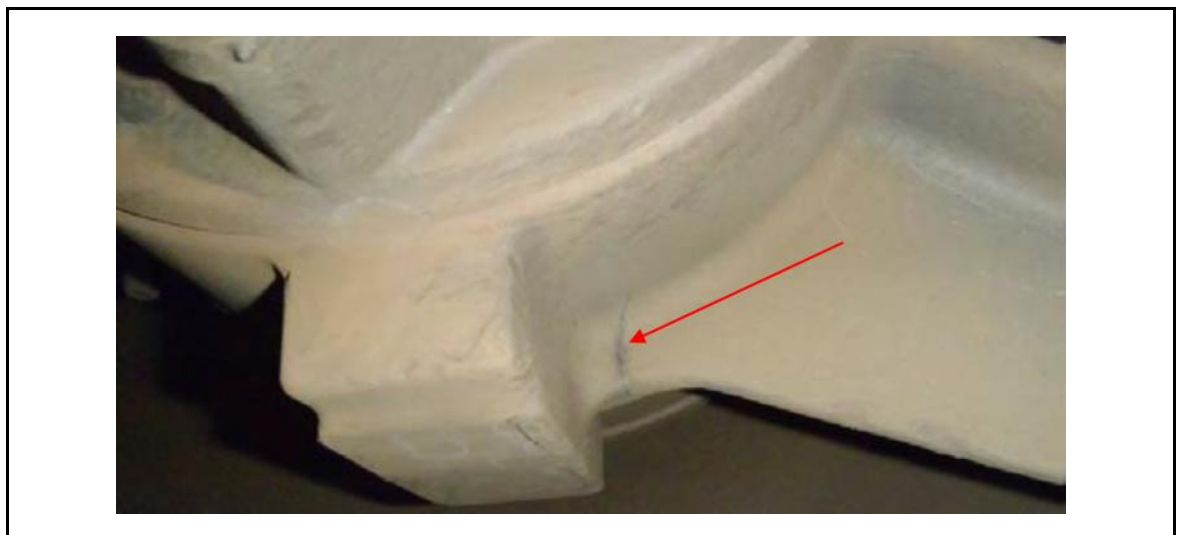
**figure 10-8:** Cracked primary damper supports under the damper support arm

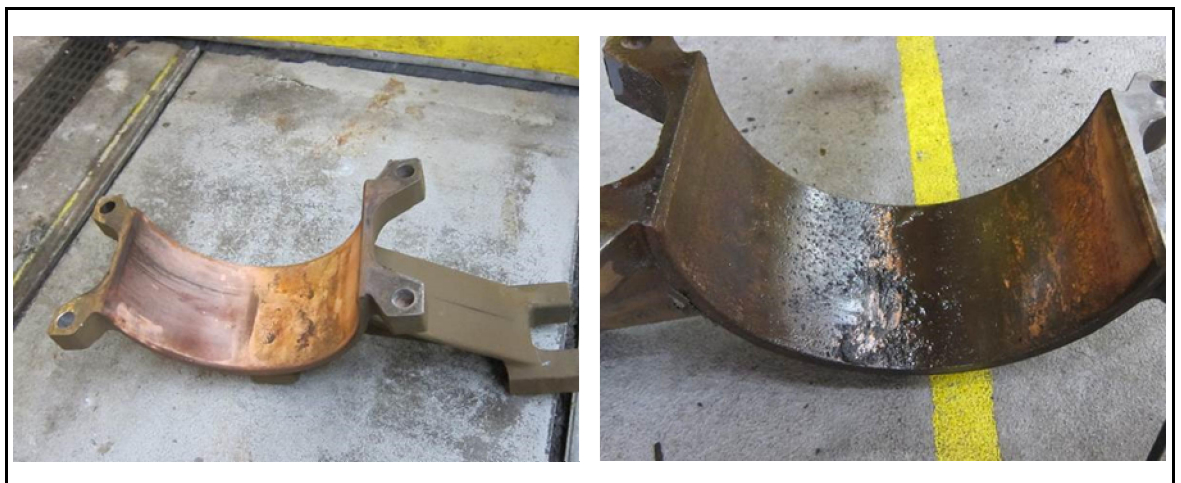
In general the FEA (A2, 117/163/164) provides no explanation for the existing failure at this location. Independent of any material properties there is always the highest utilisation in the area of the reinforcement below the arm. Therefore, there is either an additional force present or the boundary conditions are different. On one hand it could be generated by exceptional single loads (and then developed as fatigue cracks by running on worst wheels and worst dampers) as identified by the findings of IC4PT (chapter 10.2.3.3). On the other hand the received pictures (see random collected figure 10-9) from the lower axle box housing show marks like fretting corrosion which is an indication for geometrical interferences or local deformations caused by inclination of the bearing. Knowing that the investigation reports carried out by FAG itself or FORCE (A2, 162/166/167) give no explanation for the failure over the arm it is recommended to invalidate this assessment for this failure.

**figure 10-9:** Pictures of axle box lower parts with fretting corrosion marks

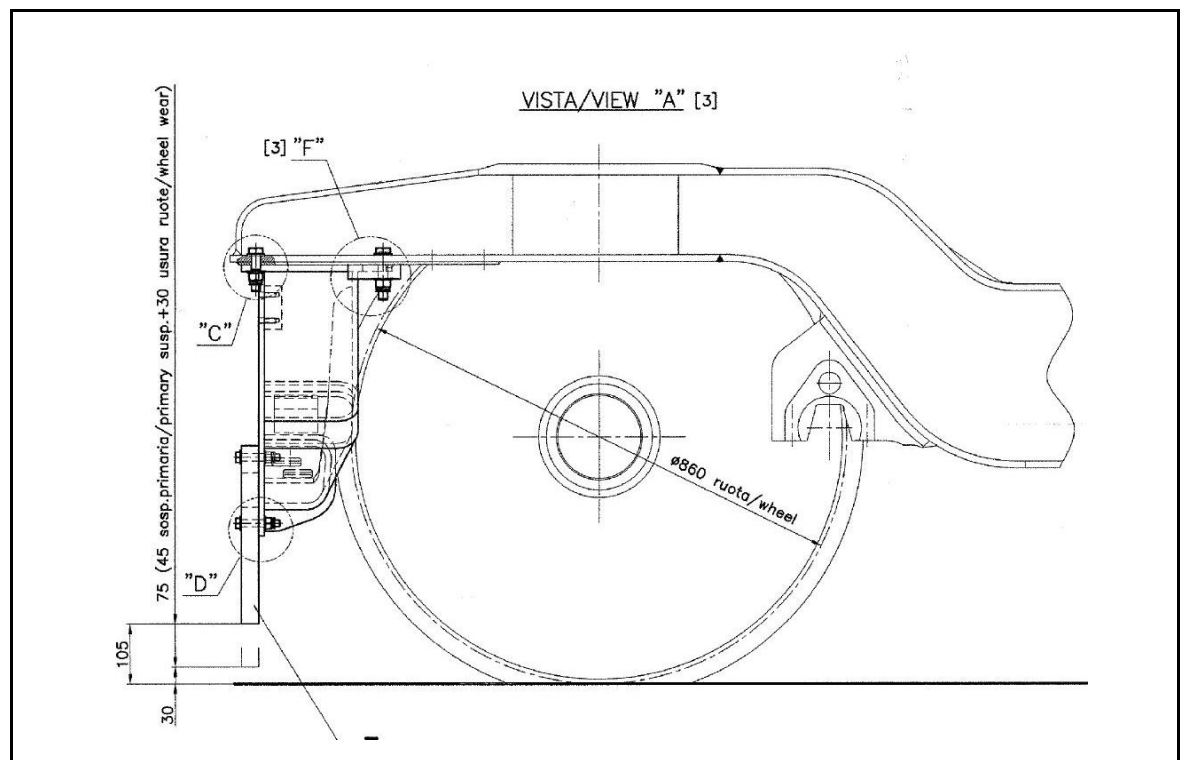
figure 10-10: Rail guard mounting (A2, 352)

It has been stated that initial cracks may cause by obstacles on the track. This has not been avoided by the rail guard since this element is design for worn wheels and not for new wheels refer to figure 10-10. To avoid future collision with larger objects this rail guard can be lowered in such a way that the wear of the wheels can be corrected by shimming or similar.

To ensure that the out-of-roundness of 0.4 mm is under control the wheel maintenance manual should follow EN15313 which allowed a maximum of 0.3 for this type of trainset.

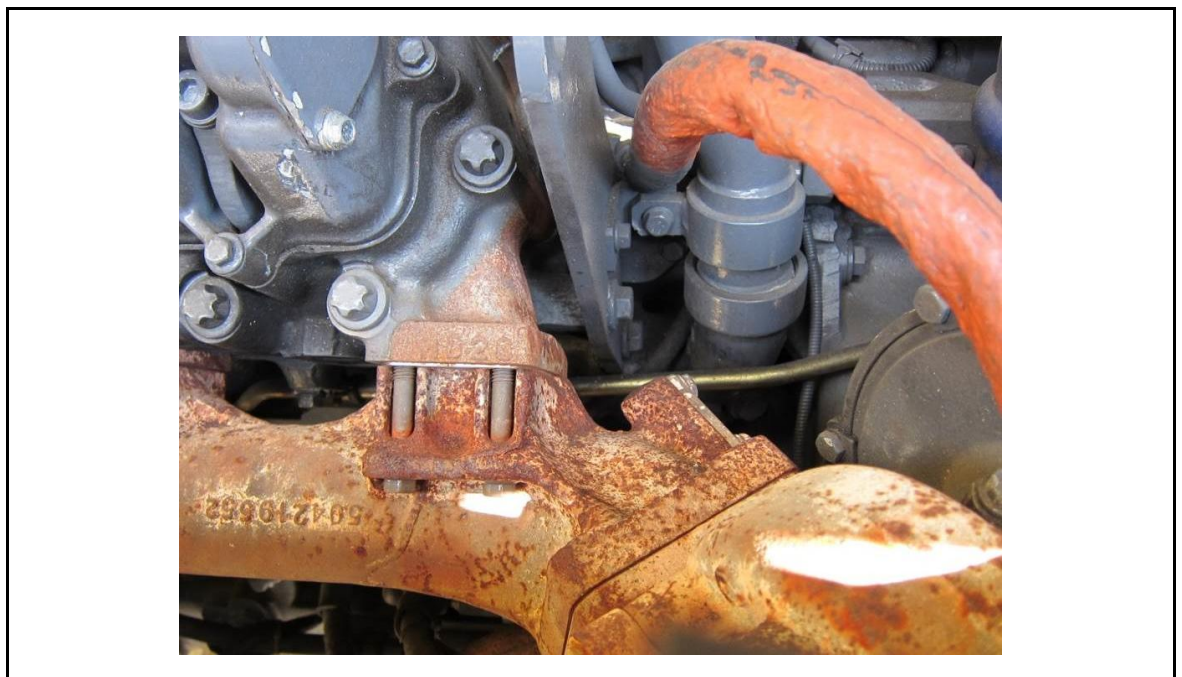
CFG-DSB0131 was opened in July 2012 because of broken bolts on the manifolds (A2, 254). The bolts are close to the turbo chargers on both sides of the motor.

**figure 10-11:** Bolts for the mounting of the manifold close to the turbo charger (A2, 254)

The root cause has been quickly identified as being the weight of the turbo chargers that are eccentrically mounted, yet being only fixed by the manifolds. Due to the running dynamic loads on the turbo chargers, the manifolds and the bolts are highly stressed.

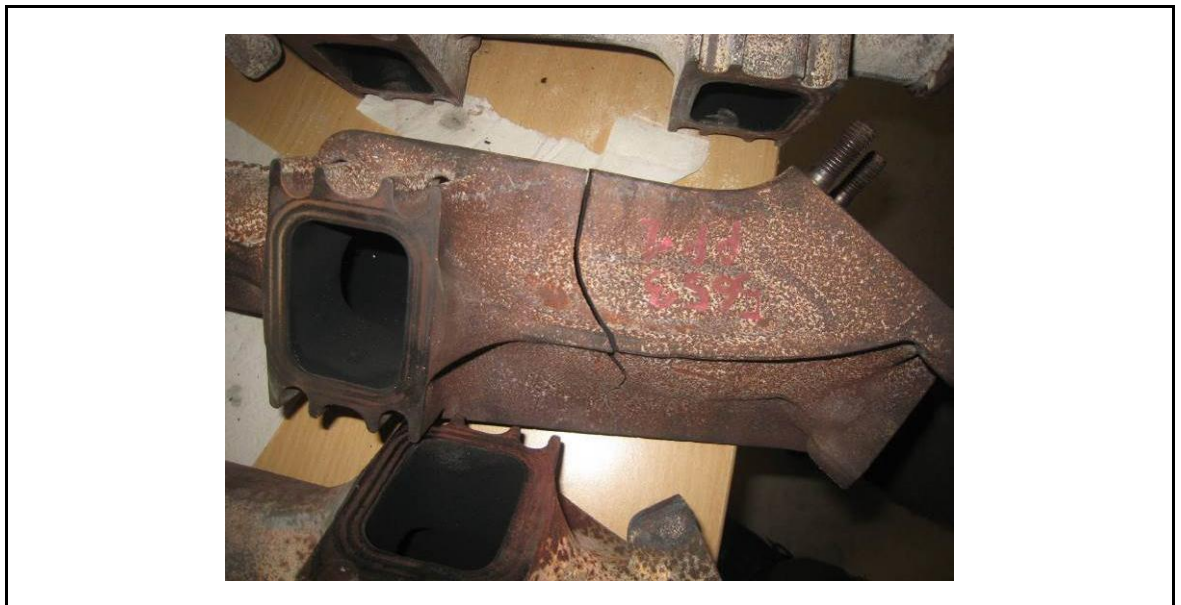
In June 2014 cracks have been found on the manifolds. The cracks are along a 45° line between the bolts and the turbo charger.

**figure 10-13:** Crack in the manifold between the turbocharger and the rear cylinder (PROSE)

As a palliative measure a regular visual check of the manifold was defined. 11 manifolds were found with cracks (A01, 25).

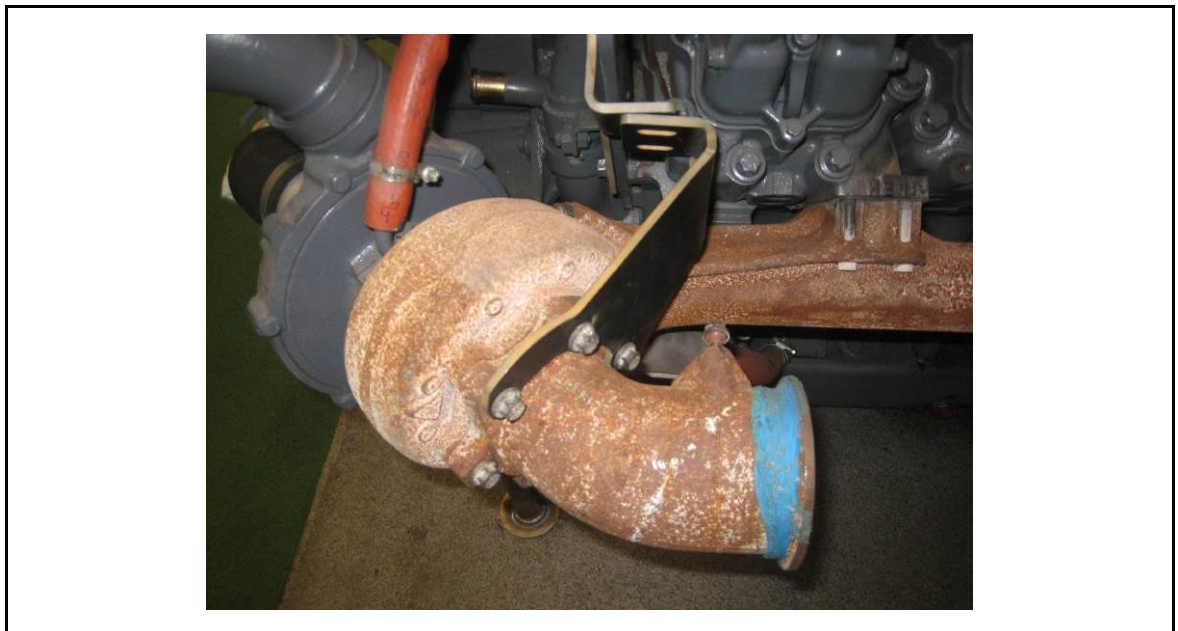
figure 10-14: Solution developed by DSB (PROSE)

DSB is also exchanging with railway operators and suppliers who experienced this problem. In parallel DSB developed internally a solution that seems adapted.

The solution has to be tested in dynamic run considering that it's only after a high mileage (at least 200,000 km) that the effectiveness of the solution will be known.

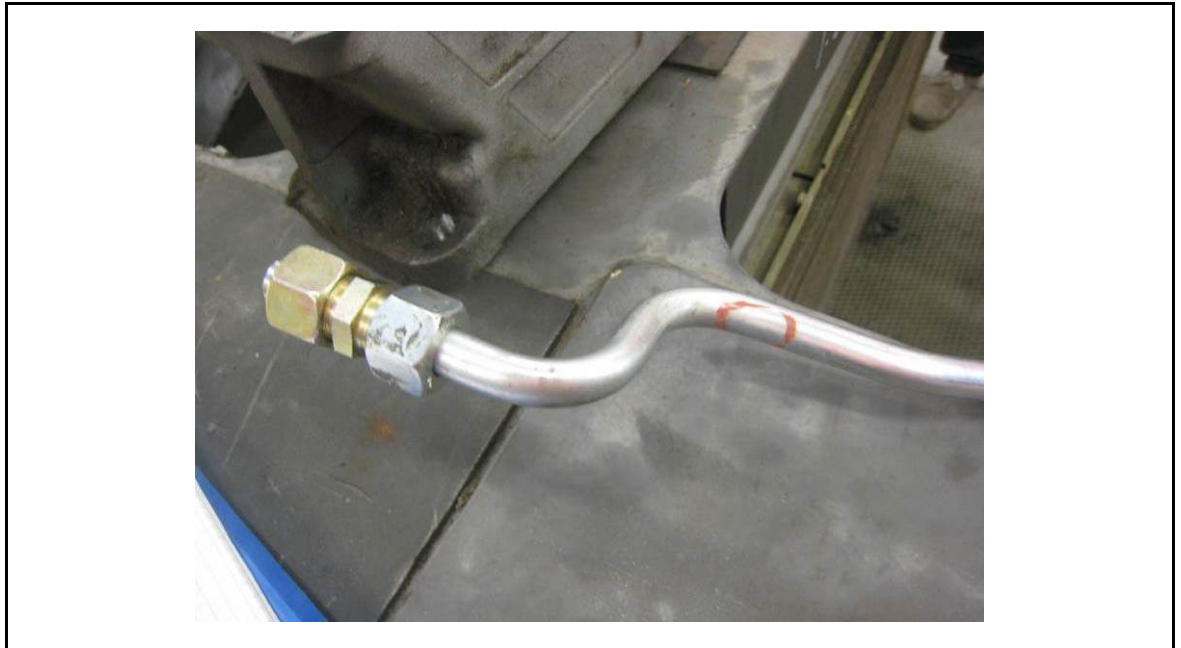
When the engine is running the primary pump ensures the fuel supply inside the pipe. In case of a leakage there is no direct way to detect that fuel is lost. As leakage of fuel oil is

considered as a high risk, an inspection of the pipe concerned is performed every 7<sup>th</sup> day of operation (A2, 402).

**figure 10-15:** Area in the fuel pipe where the leakage appears (PROSE)

DSB performed a risk estimation considering the real frequency of the leakage with the result that the risk is undesirable (A2, 405). Therefore the risk estimation will be sent to DSB safety and mitigation actions have to be implemented.

DSB developed a first prototype of new fuel pipe based on the Aeroquip FC510 hose (FC510-08) (A2, 251/302). The hose is adapted to the application, withstanding fuel and lubrication with an operating temperature up to 150°C. The minimal acceptable bending radius of the pipe is 127mm, which is higher than the bending radius of the original pipe. Therefore an adapted connection has been designed by DSB.

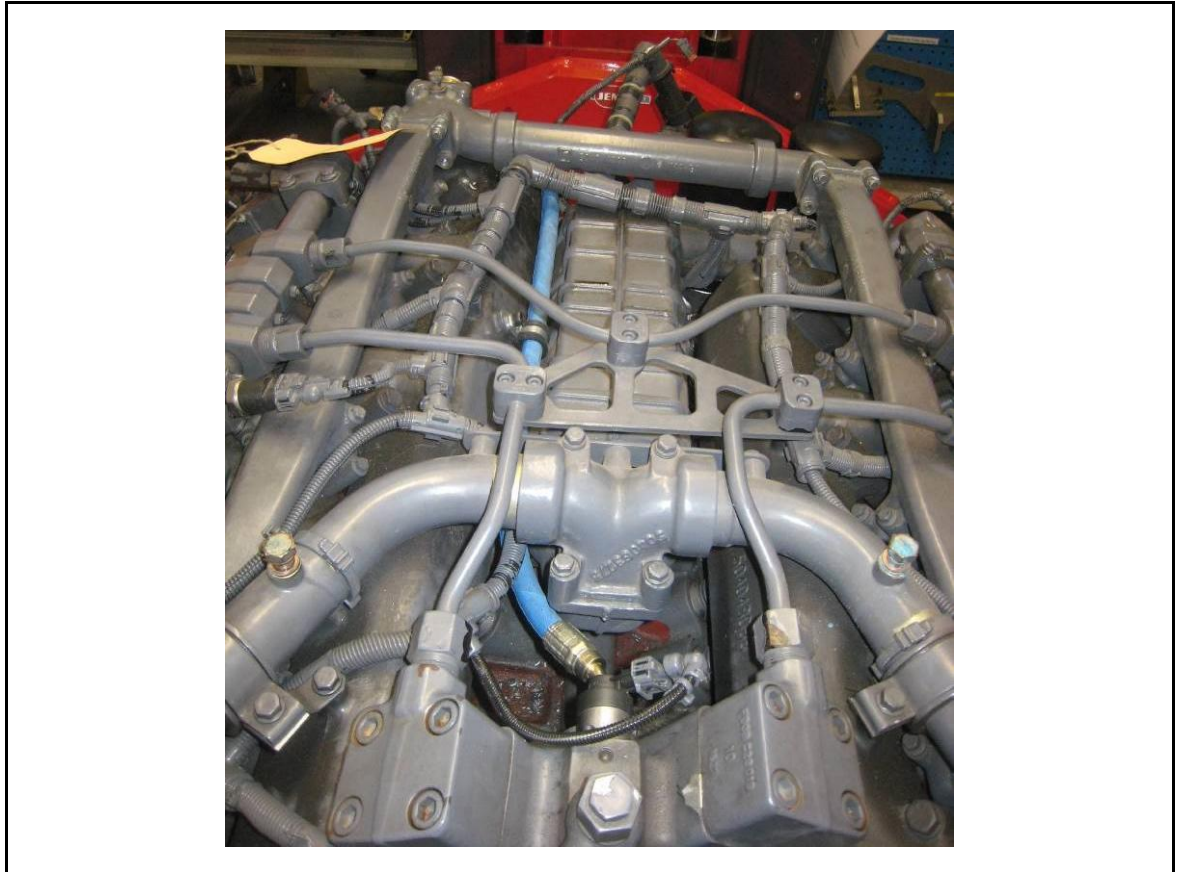
**figure 10-16:** Prototype based on FC510-08 hose from Aeroquip with the adapter for the connection to the high pressure pump (PROSE)

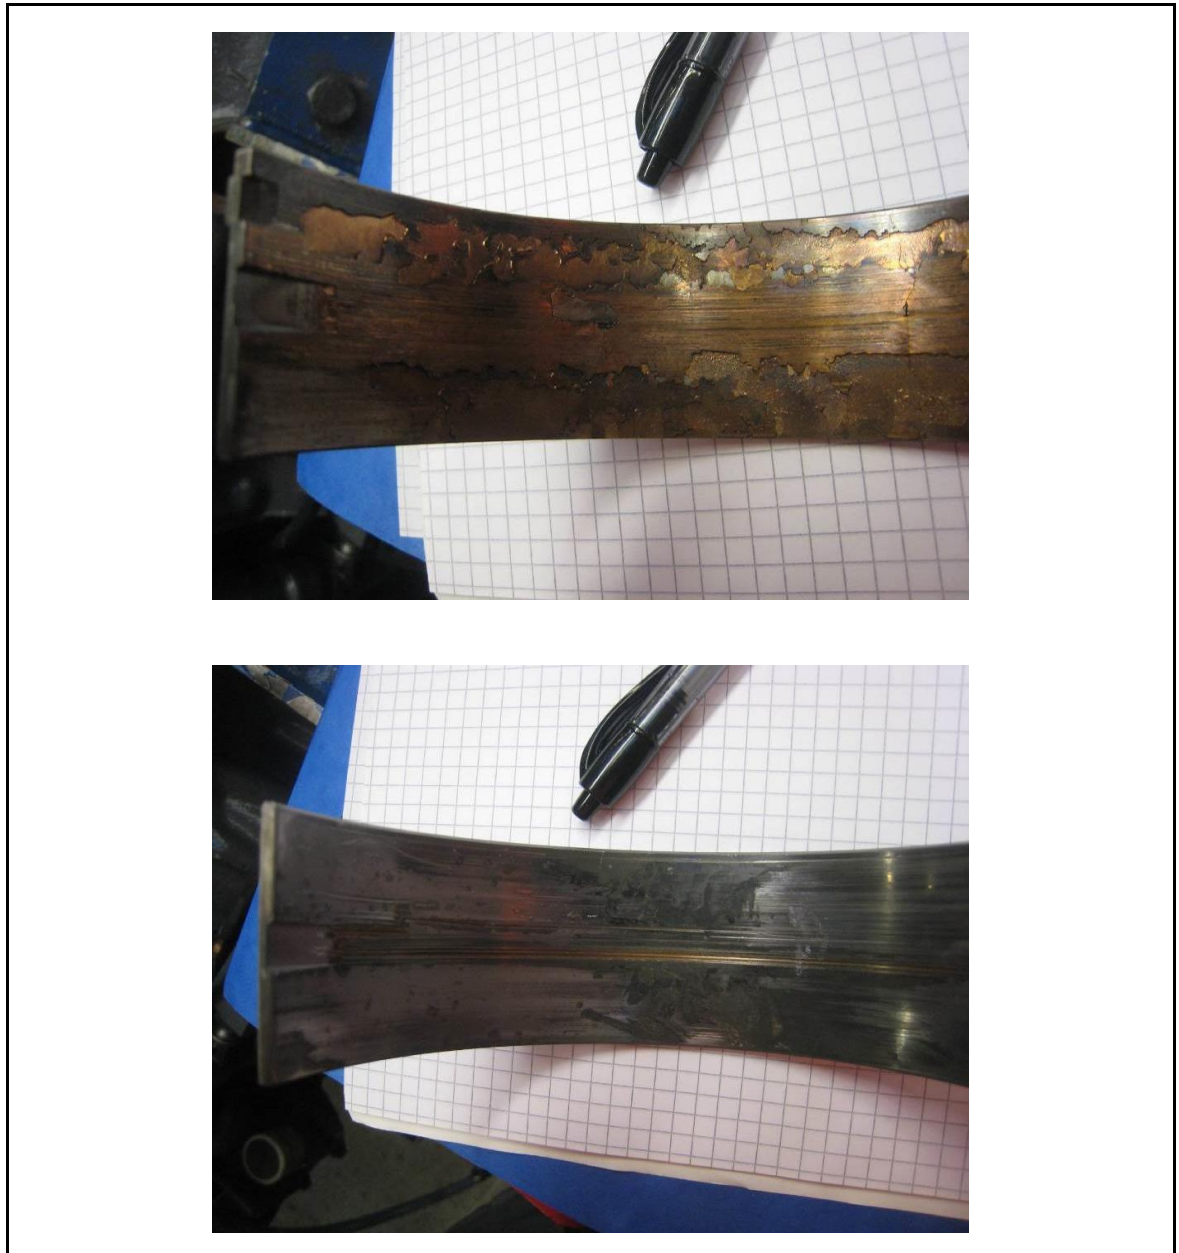
DSB started the technical investigation but it appears that the investigation is delayed because of the lack of available resources. The technical and financial risks connected to these breakdowns cannot be estimated today.

figure 10-17: Damaged radial thrust bearing: spalling, grooves and corrosion are visible (PROSE)

- RCA of current breakdowns of the crankshaft bearings in the engine in order to identify the root cause of the damaged bearings, which may concern the entire fleet or not, and to define specific corrective actions.

PROSE recommends the implementation of a task force to assess the risk of a design failure and to define the specific corrective actions.

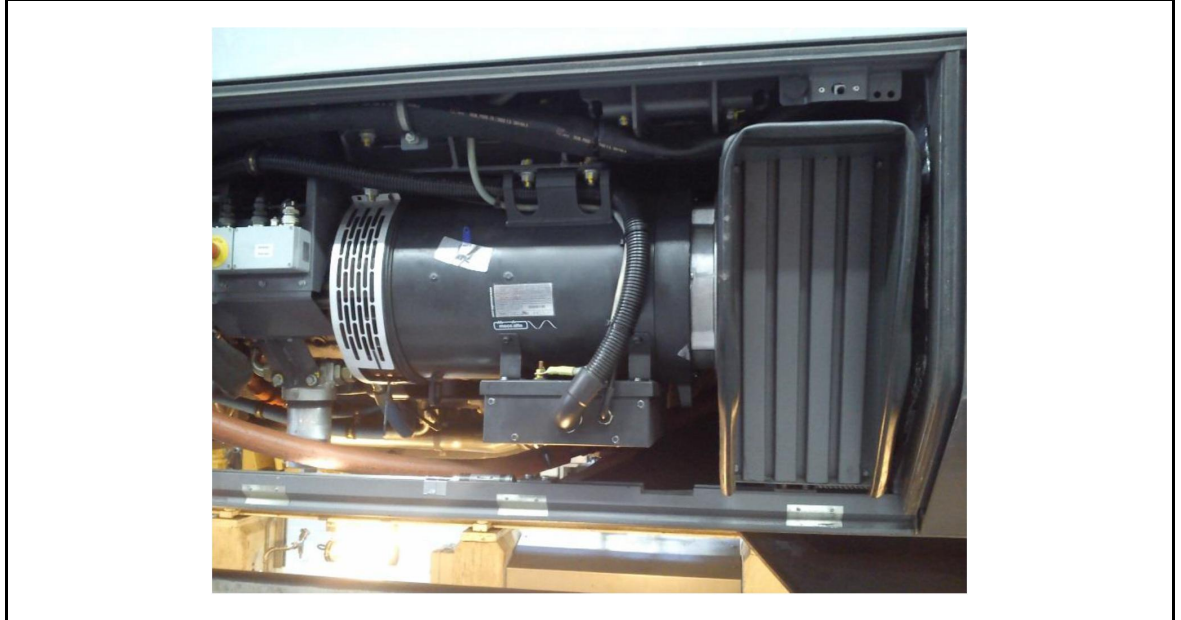
**figure 10-18:** Alternator with the new air outlet grid (left side) (Shown without side skirt) (A2, 180)

After the implementation of the new air outlet grid, an airflow of  $16.17 \text{ m}^3/\text{min}$  has been measured (A2, 141). This is still approx. 30% lower than the air flow specified by the alternator manufacturer (A2, 233). Additionally it hasn't been verified if the ambient temperature of the alternator is within the specification.

To improve the airflow through the alternator, the air outlet has been enlarged by replacing the cover with a grid.

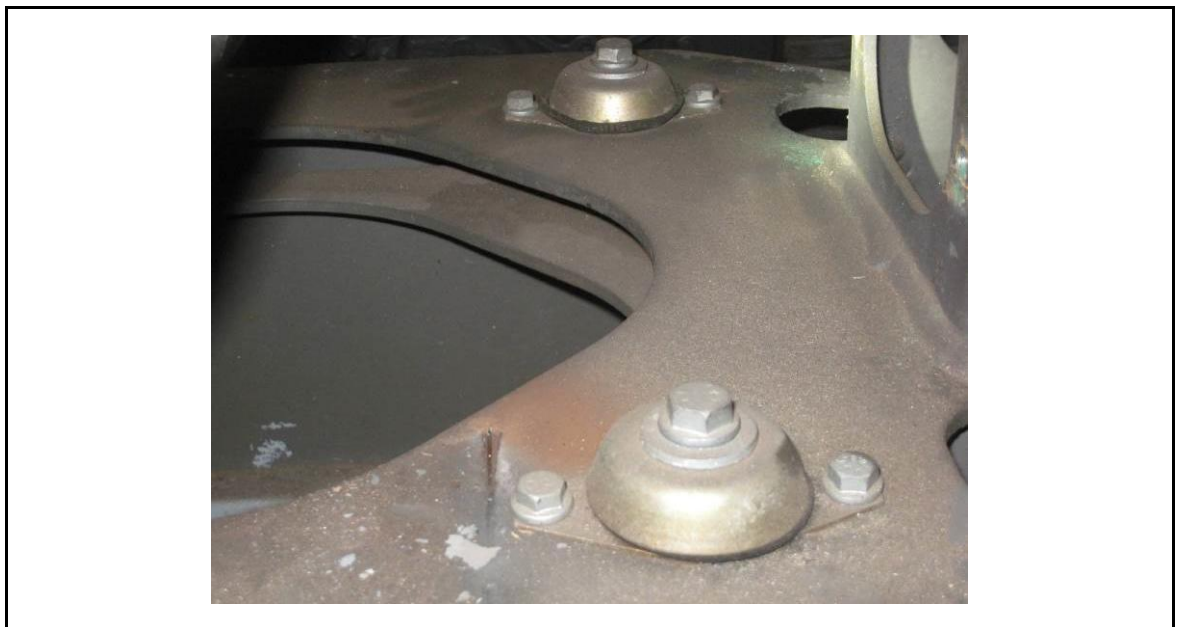
- RIT032: The main hydraulic pump is mounted suspended to the power pack frame with a rubber element. Because of the heated environment and the creep of the rubber, the misalignment of the pump and the motor exceeds the acceptable tolerances and the rubber coupling is damaged (problem similar to CFG-DSB0092). The problem is actually managed by the maintenance through curative actions: shims are added in order to compensate for the creep and deformation of the rubber elements. The definitive solution is not trivial because the deflexions of both the motor suspension and the pump suspension have to be compensated for. No CFG has been issued yet.

**figure 10-19:** Damaged rubber element for the fixation of the main hydraulic pump (PROSE)
