## Report 04-03-00974 Rev. 0.00

DSB - Expert Assessment of IC4/2

## EXPERT ASSESSMENT REPORT IC4/2

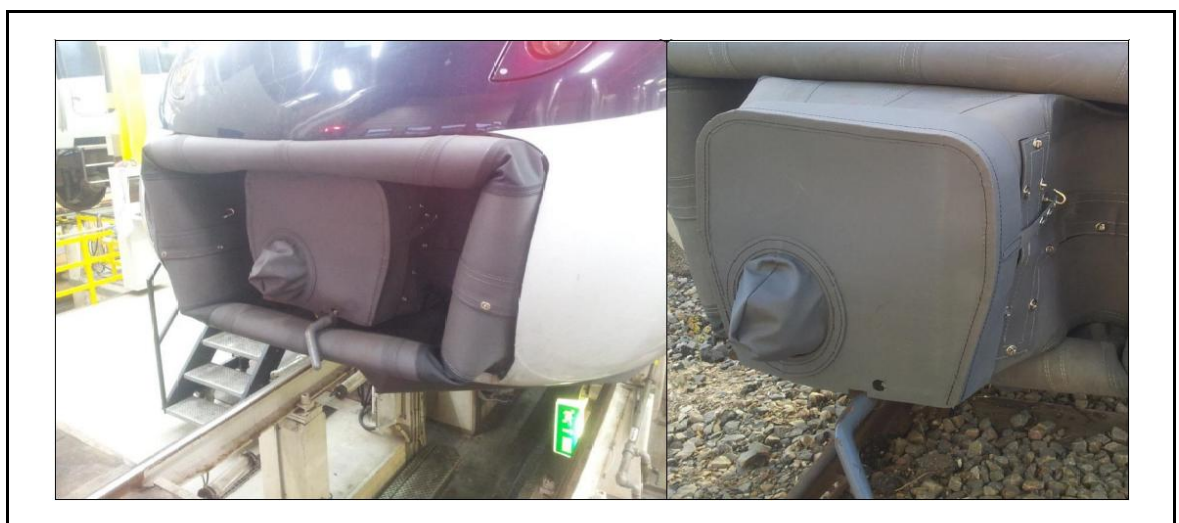
figure 10-1: New gaiter; left picture: coupler retracted; right picture: coupler extracted (A2, 222)

Thus, several actors and sensor fall away and the control within the TC software has to be removed. This update of the TC software has been rejected (A1, 27) and therefore an electrical modification has been specified in the CFG-DSB0168 to replace the signals of the missing components (A2, 223). That means the electrical change is only required to simulate to the TC software that the sliding covers are still available.

Although this is not the preferred way to do it, the solution is proper and fulfils the requirement. The update of the TC software is planned at a later stage.

For the new gaiter a requirement specification has been elaborated and a public tender announced (A2, 095). During January 2013 IC4 trainsets have been equipped and tested with three prototype gaiters each produced by one of three different suppliers (A2, 154). The gaiter produced by Dellner has been selected by DSB (A2, 152). Dellner has similar gaiters already in operation in Sweden and Norway for over 10 years (A2, 335).

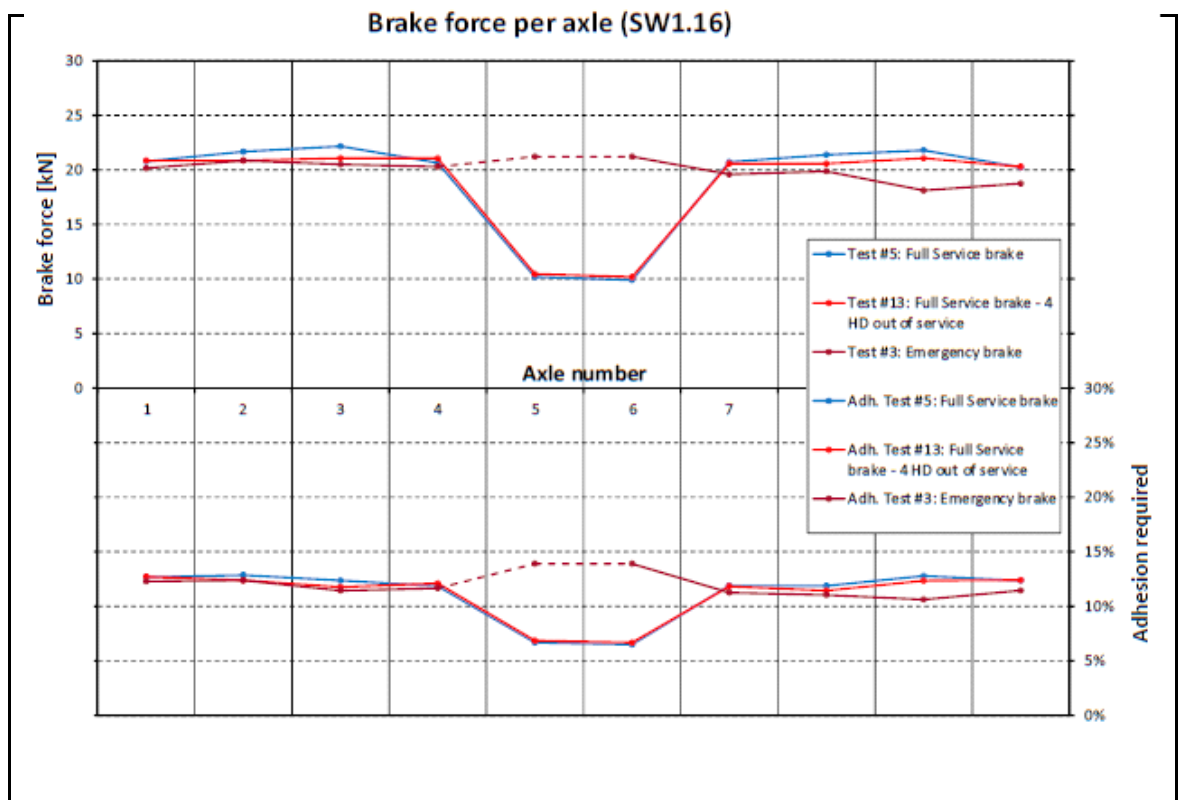
figure 10-5: The new blending philosophy according to FT values (A2, 401)

According to the on vehicle type test report provided by Faiveley Transport (FT) (A2, 401) and in order to have a first estimation of the brake force repartition (distribution) for the assessment of this report the brake forces were calculated from the measured cylinder pressure values and achieved HDB force values using the mechanical parameters from the former calculations (A2, 045/046). The distribution of the calculated brake force to the axles and the related required adhesion are given in figure 10-5.

It has to be pointed out that the calculated brake force values may differ from the real values. Therefore a detailed analyse should be done by the IC4PT brake task force team with the exact values.

It can be noticed that the calculated brake force is not equally distributed between the axles as specified and required (figure 10-4):

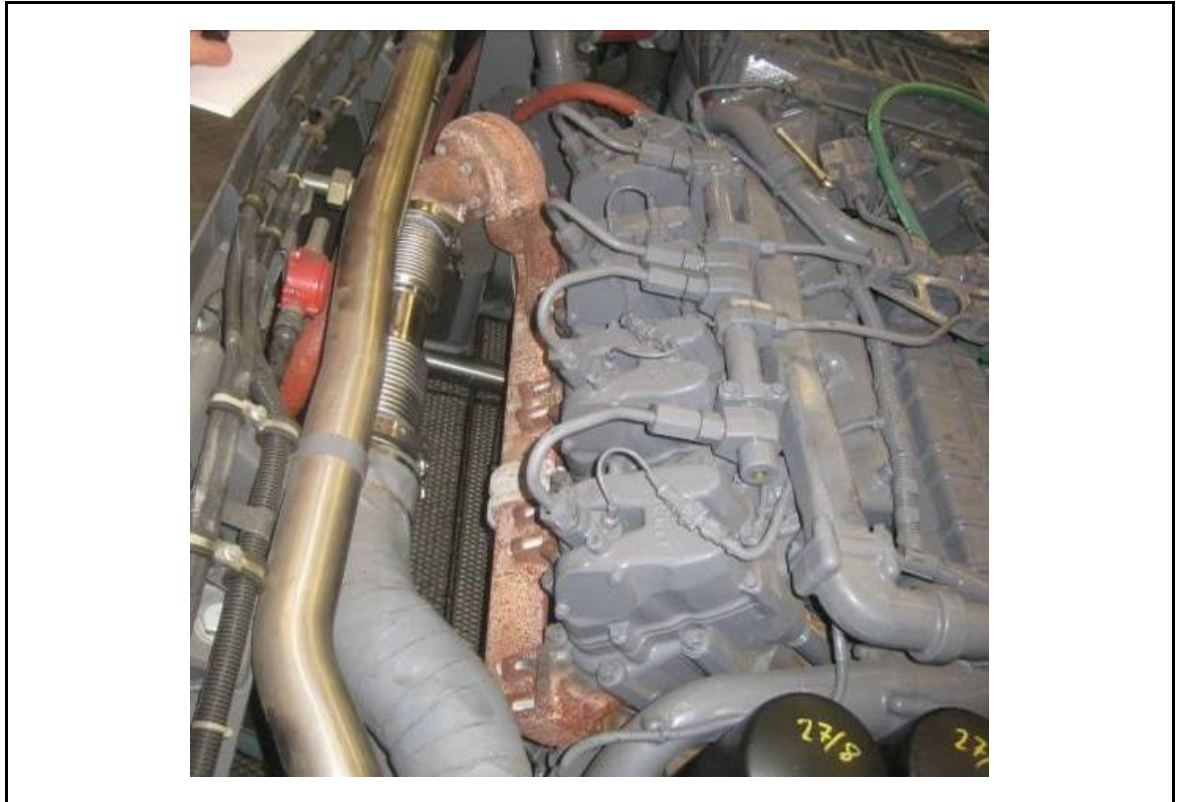
**figure 10-12:** Manifold and turbo charger mounted on the side of the engine (PROSE)

The root cause has been quickly identified as being the weight of the turbo chargers that are eccentrically mounted, yet being only fixed by the manifolds. Due to the running dynamic loads on the turbo chargers, the manifolds and the bolts are highly stressed.

In June 2014 cracks have been found on the manifolds. The cracks are along a 45° line between the bolts and the turbo charger.
